**Claudia Zanlungo,
Anna Maria Basso Bert
(Brescia)**

Preservation Strategies for Sabbioneta's City Walls and Recent Restorations

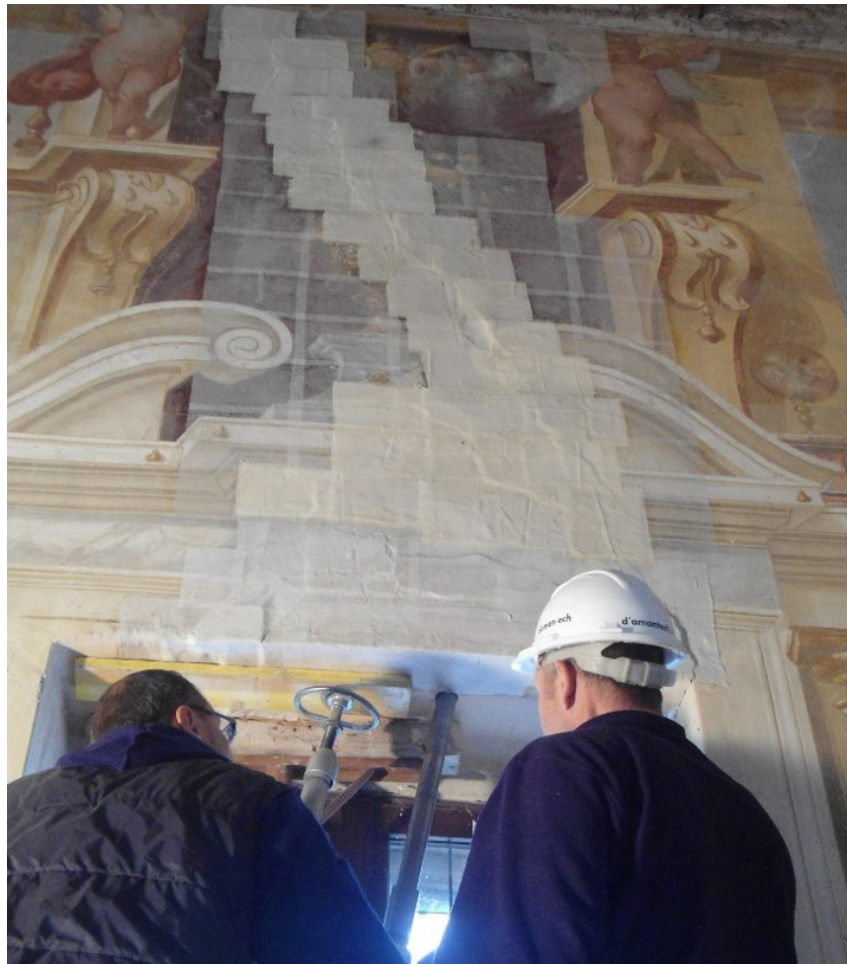
Abb. 3. Galleria degli Antichi. Temporary consolidation works on damaged frescoes through application of a protective coating of Japanese paper aimed to prevent further damage that could be caused by the consolidation works on cracked walls. The seismic events of May 2012 were strongly felt both in Mantua and Sabbioneta: numerous buildings were affected by the earthquake and, in the southern portion of the Mantua province (*Oltrepò mantovano*), 51 municipalities had been affected, with a total amount of 567 damaged buildings (notably including more than one hundred churches). A task force was established, chaired by the local Superintendent, to oversee the assessment of the damage and plan reconstruction activities. Several consolidation works were authorized to ensure the future stability of the structure and, after 4 years, a large part of these works has been completed.
Foto: Soprintendenza Archeologia, Belle Arti e Paesaggio per le province di Cremona, Lodi e Mantova.

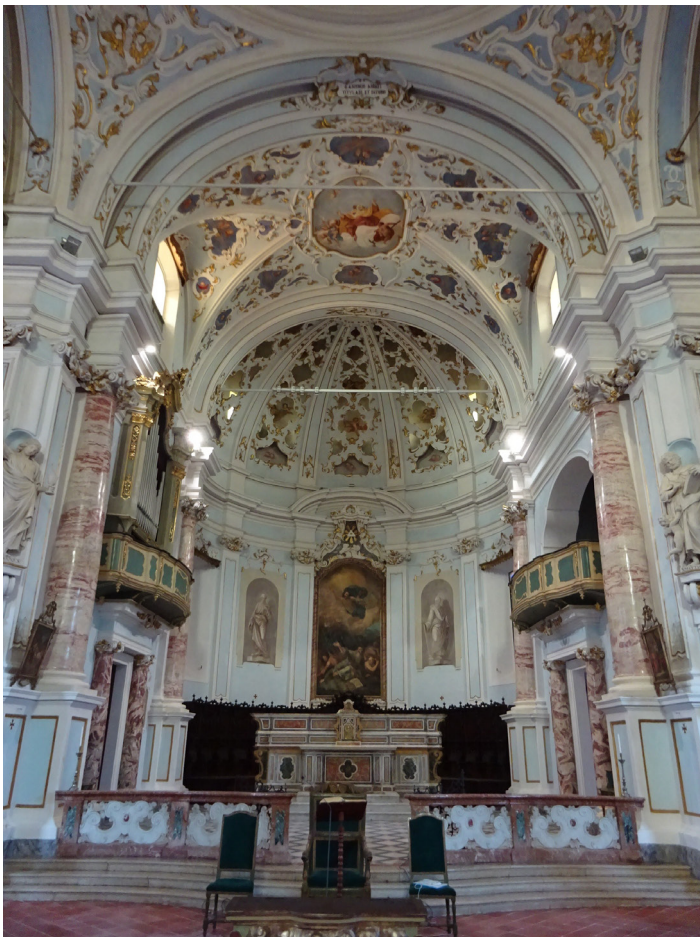
Abb. 4. Church of Saint Antonio in Villa Pasquali. Seismic improvements works, repair and conservation works have just been completed. Foto: Soprintendenza Archeologia, Belle Arti e Paesaggio per le province di Cremona, Lodi e Mantova.

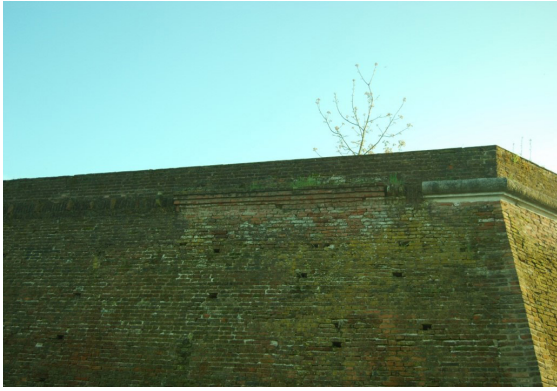
Abb. 5, 6. Fotos: Soprintendenza Archeologia, Belle Arti e Paesaggio per le province di Cremona, Lodi e Mantova.

Sabbioneta's city walls are evidence for the use of different theoretical approaches: for example, at the beginning of the FIO works it was decided to replace lost bricks with reused material (old and restored bricks); because of the very high costs of this procedure, in accordance with our office it had then been decided to use new bricks, distinguished from the original ones by a "sanding surface". It had also been determined not to replace missing pieces of the bullnose element with original shaped bricks, in spite of emphasising the continuity of the bullnose with a different layout of new bricks. This methodology complied the theoretical principles of "recognition of the new elements" and of economical sustainability (Abb. 5).

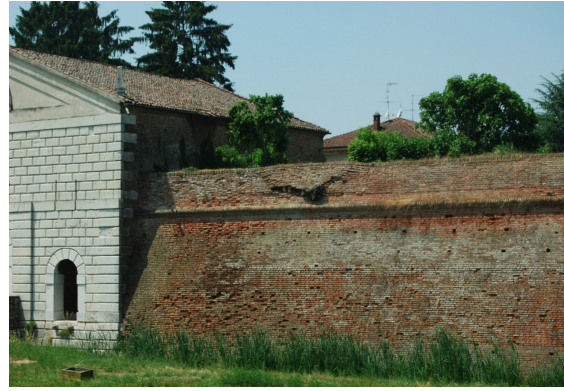
- For example, on the wall right next to the Imperial Gate, very deep roots of a big fig tree caused serious structural problems and the expulsion of the crown (Abb. 6).
- Some parts of the walls showed an entire loss of the crown including the bullnose brick element, which in some cases had fallen down together with the corbels. This degradation is due to vegetation which caused the deep disintegration of the brick structure and could lead to its collapse. On the other hand, the masonry is supported and held together almost exclusively by soil and roots. Last but not least, it has to be noticed that the loss of the crown itself can aggravate the degradation process of the masonry wall (Abb. 7).
- Deep joint erosion is in many cases caused by crystallisation of cement mortar, an inadequate past intervention (Abb. 8).

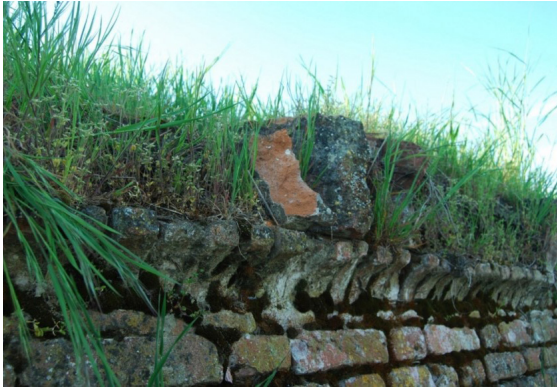
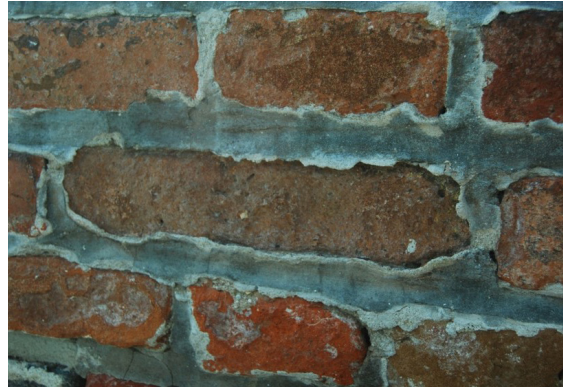
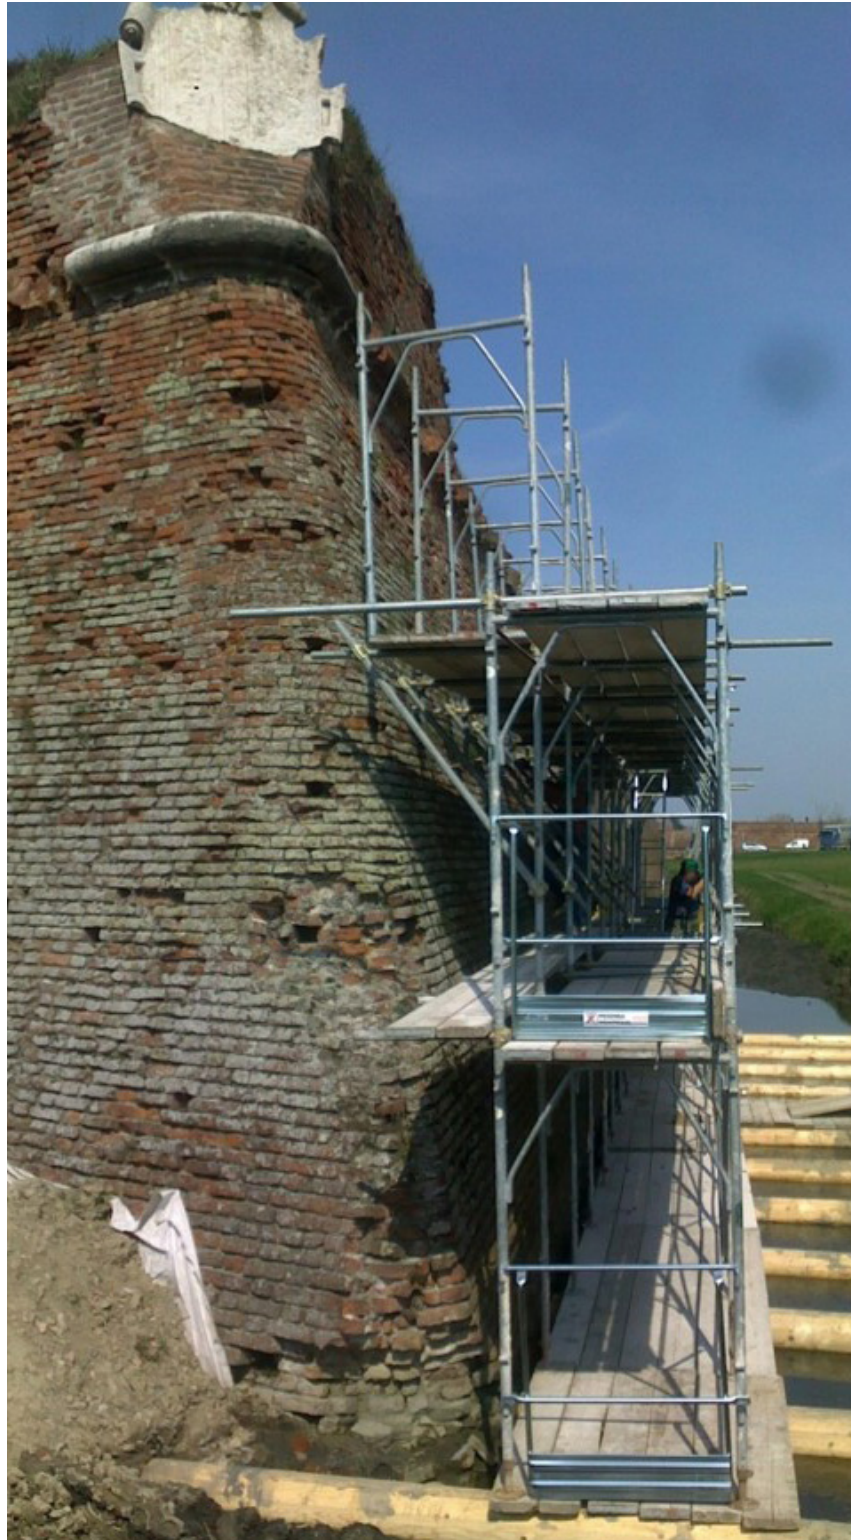
Abb. 7–9. The installation of the scaffolding system required special attention, since several problems occurred during the construction as result of the difficulty of controlling water levels in the moat, that sometimes exceeded the first floor level. The bottom of the moat was prepared with timber structures to support the metal ones. Fotos: Soprintendenza Archeologia, Belle Arti e Paesaggio per le province di Cremona, Lodi e Mantova.

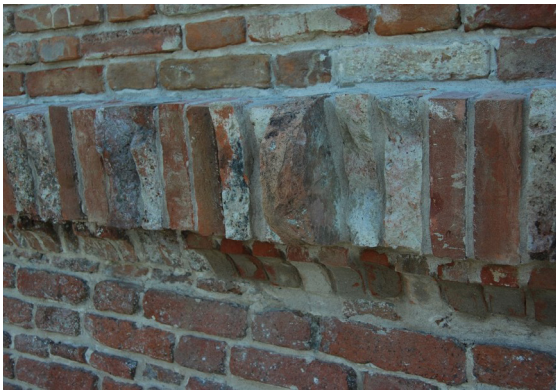
Abb. 10–13. Fotos: Soprain-
tendenza Archeologia,
Belle Arti e Paesaggio per le
province di Cremona, Lodi e
Mantova.

- The aforementioned operations should be repeatedly carried out on small sections of the Walls in order to permit a controlled repositioning in the same location and to ensure both material and architectural authenticity. This last requirement of our office was not fully respected and a significantly long portion of the bullnose was entirely removed from its position, located on the scaffolding in a disorderly manner and waited to be rebuilt in a random way. To try to solve this problem and to give continuity to the visual presence of the bull line, our office asked to leave the existing structure visible and to complete the missing parts by placing a brick on its side only to give the idea of the change of texture and without reproducing the brick-shaped element (Abb. 10).

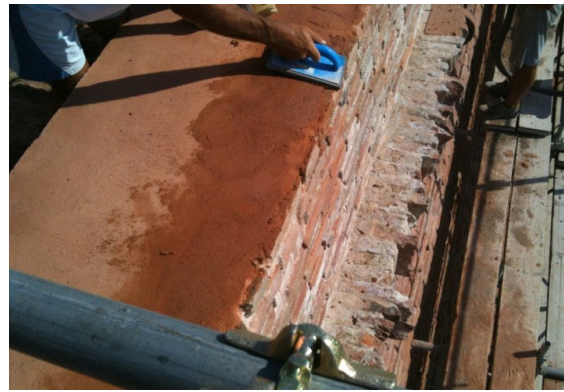
- In order to protect the top of the wall it was decided, following the FIO experience, to lay a layer of earthenware mortar to prevent water infiltration. Our Office asked to build this "copertina" slightly curved (Abb. 11).

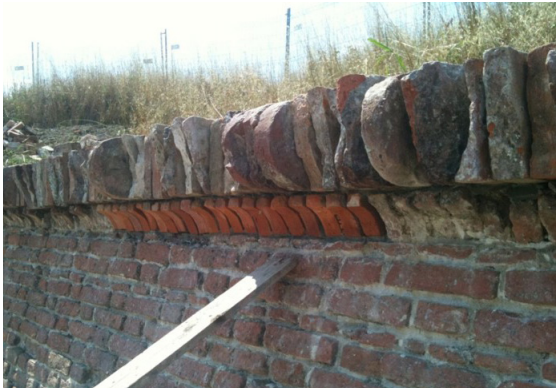
- The most severe degradation regarding the wall sections were where the bull remained unprotected, as the wall crown had disintegrated a long time ago: the result of this situation was a disintegration of the bull-nose element as well as that of the underlying structures. In case of corbel losses, it was agreed to use new clay elements, shaped in the same way like the original ones but clearly recognizable (Abb. 12).

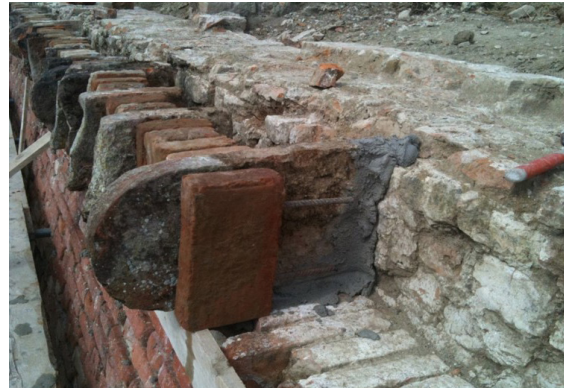
- The reconstruction of the parapet above the bull had to concern the total depth of the original construction and to be crimped

to the interior masonry buttresses; when the new elements of the bull-nose, which fills some gaps, could not be topped by a new crown wall, it was decided to fix them to the adjacent elements with metal pins (Abb. 13).

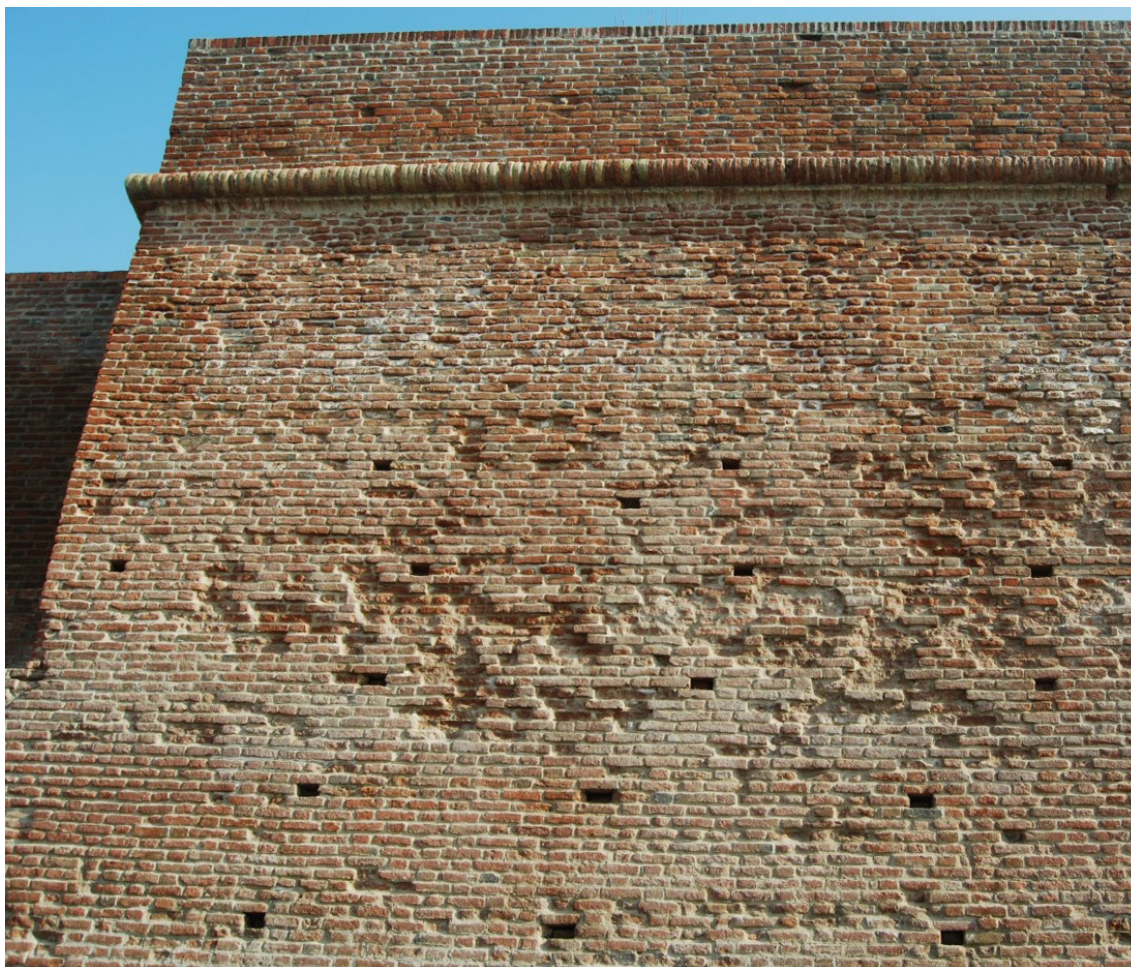
Abb. 14. Foto: Soprintendenza Archeologia, Belle Arti e Paesaggio per le province di Cremona, Lodi e Mantova.

- When structural problems were not present it was aimed to respect the minimum intervention dogma. It was chosen to maintain the gaps in the facing bricks: on the other side, such a decision that was taken in agreement with the municipality requires a continuous maintenance of the walls and a correspondent increase in preservation costs (Abb. 14).
- Those sections in which the fig tree roots had caused the expulsion of the upper part, it was necessary to remove the corresponding section of wall because its shape was extremely deformed. The dead tree was cut off flush with the bank while keeping its roots in their home. The wall was then reconstructed with the same construction technique.
